FINAL REPORT SEPTEMBER 1989

REPORT NO. EVT 31-89

EVALUATION OF THE RAILROAD BOXCAR LADING STRAP ANCHORS ADAPTABLE TO 1 1/4-INCH STEEL BANDING

U.S. Army Armament, Munitions and Chemical Command ATTN: AMSMC-TM Rock Island, IL 61299-6000 Distribution Unlimited

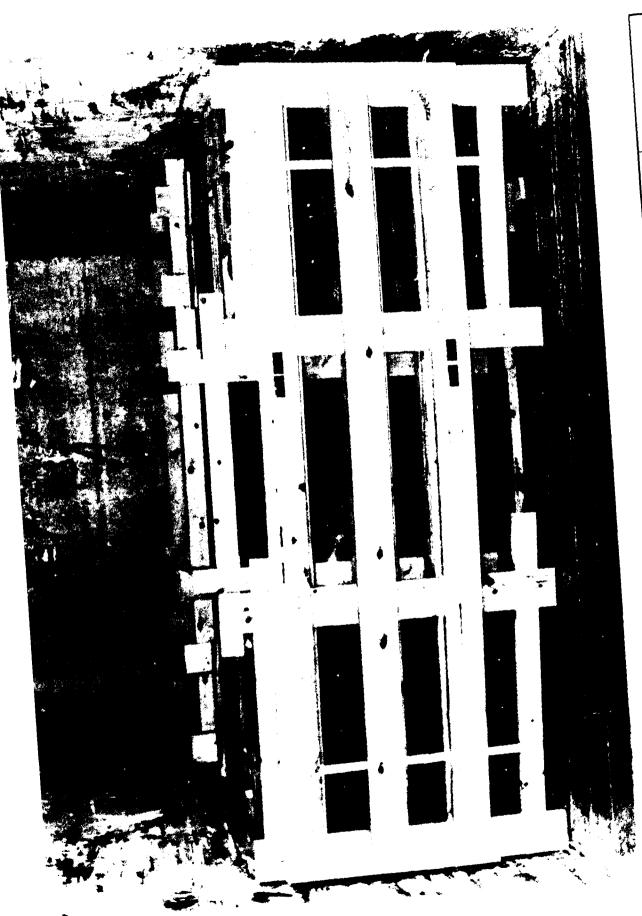
Photo No. AO317-SPN-89-962-4188. View of the two 1 1/4-inch steel straps across the strapping gate restraining the six pallets of propelling charges. U.S. ARMY DEFENSE AMMUNITION CENTER AND SCHOOL - SAVANNA, IL

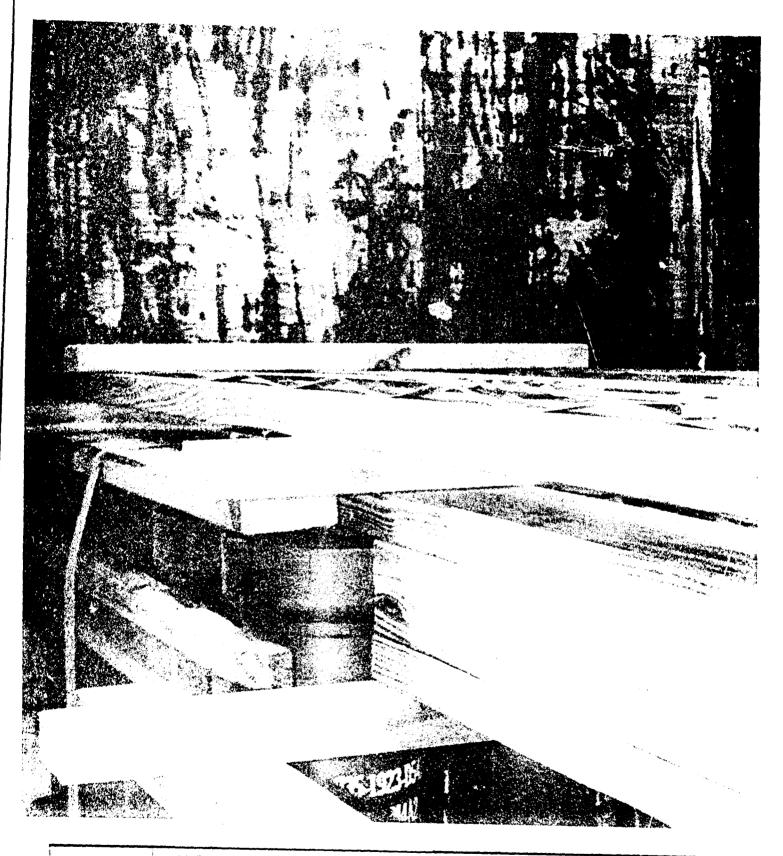
Each bulkhead steel strap consisted of two pieces. Each piece was threaded through the railroad boxcar strap anchor device, and the strap secured at the anchor point with a seal located 18 inches from the anchor device. The inside strap from each side was tensioned and sealed across the face of the bulkhead at both elevations before the second strap was tensioned and sealed. Tensioning the outer strap over the already sealed inner strap caused the inner strap to buckle and become slack.

Photo No. AO317-SPN-89-3783. View of the top 1 1/4-inch steel strap showing how the inner strap of the loop was not taut and buckled when the outer strap of the loop was tensioned.

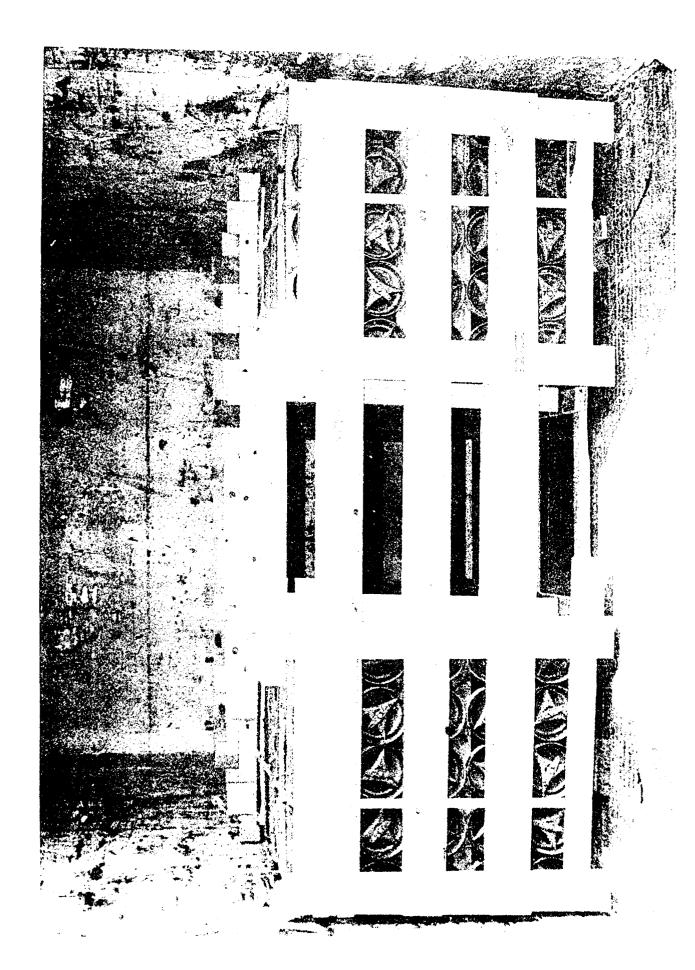
Photo No. AO317-SPN-89-3775. View of the 1 1/4-inch steel straps across the strapping gate restraining the six U.S. ARMY DEFENSE AMMUNITION CENTER AND SCHOOL - SAVANNA, IL pallets of propelling charges.

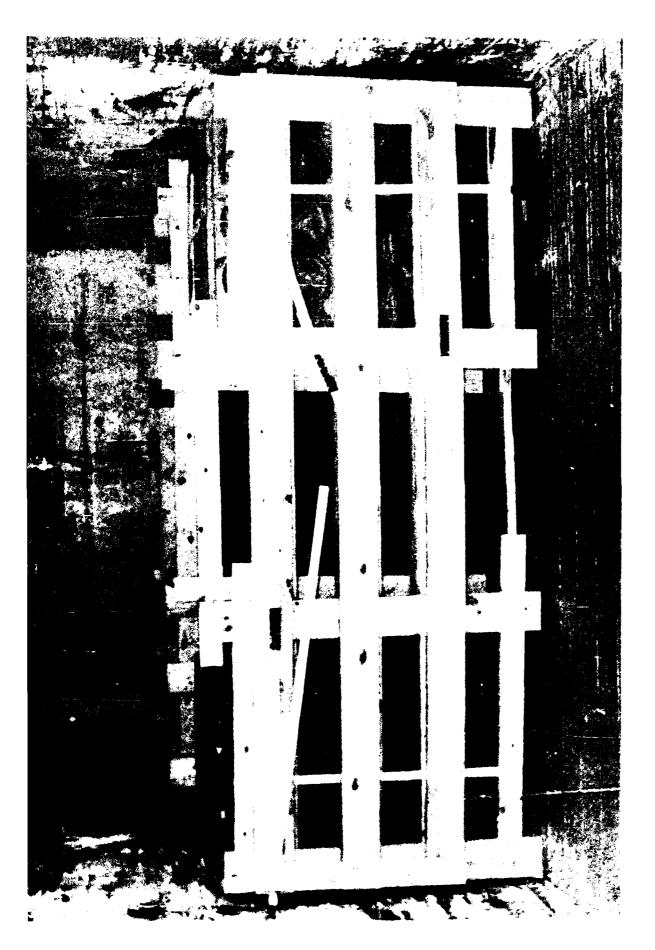
The 4 and 6 mph rail impacts were again uneventful. The third impact at 7.86 mph resulted in the upper steel strap failing at the crimp in the seal. The bottom strap loop did not fail, and both straps of the bottom loop remained in nearly equal tension.

IMPACT NO.	END STRUCK	VELOCITY (MPH)	REMARKS
1	В	4.39	Strapping gate bowed 5/16-inch at the center.
2	В	6.33	Strapping gate bowed an additional 1/8-inch at the center.
3	В	7.86	Top band broke at the crimp. Strapping gate center moved rearward an additional 3/8-inch and side moved rearward 3/4-inch. FAILURE.

U.S. ARMY DEFENSE AMMUNITION CENTER AND SCHOOL - SAVANNA, IL Photo No. AO317-SPN-89-3781. View of the failed upper strap during the 8 mph rail impact

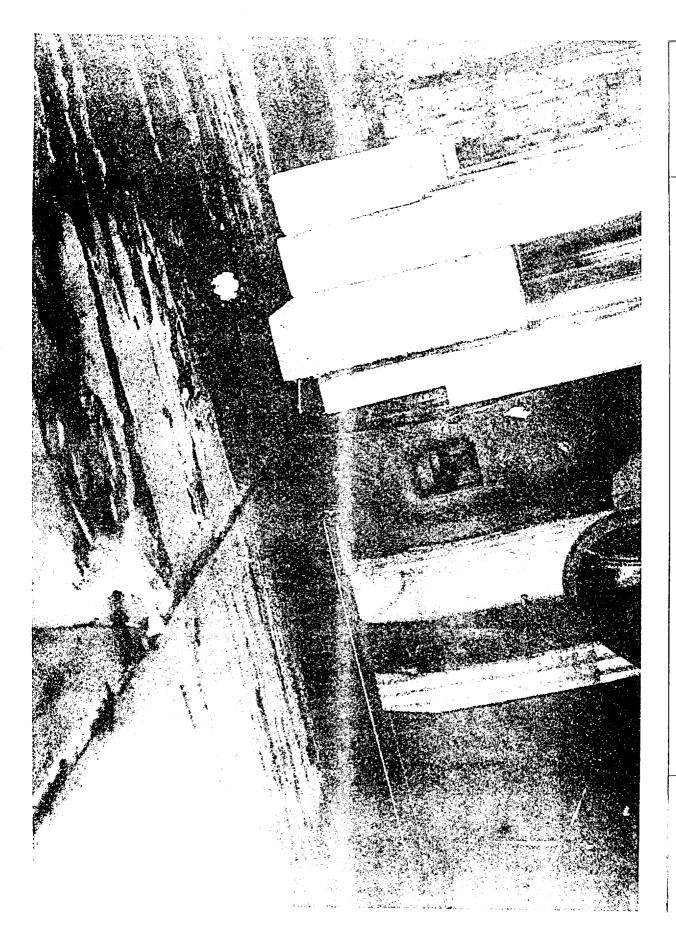
In tensioning the steel strapping for this load, the strapping was drawn against the corner of the pallet. In this case, the banding pulled against the edge of the bell of the propelling charge container. The length of this bulkhead gate was constructed two inches less than the inside width of the boxcar. The length of the bulkhead gate should be constructed 1/2-inch less than the width of the boxcar to protect the strapping from cornering against the metal edge of the bell of the propelling charge container.

strapping gate as banding was looped through the anchor and clipped. Note: Close proximity of steel strapping to Photo No. AO317-SPN-89-3786. View of the single length of 1 1/4-inch steel strapping across the face of the the edge of the bell of the propelling charge container

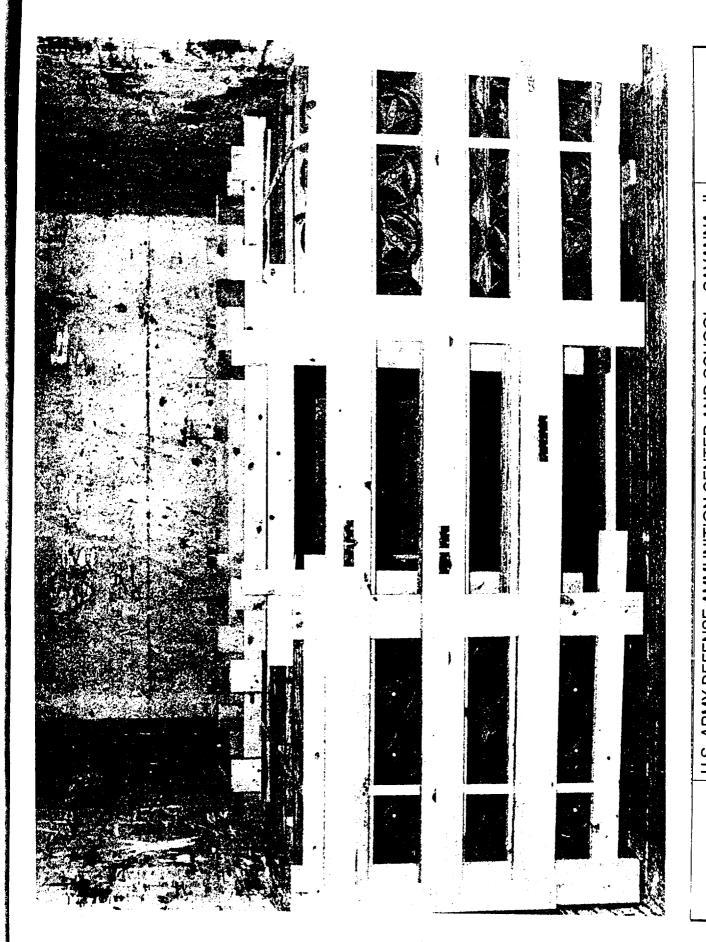
During the second rail impact at 6.24 mph, the lowest steel strap failed at the notch in both seals located adjacent to each strap anchor device in the boxcar sidewall. The upper two steel straps were not damaged.

Photo No. AO317-SPN-89-3787. View of the three 1 1/4-inch steel straps across the strapping gate restraining the six pallets of propelling charges.

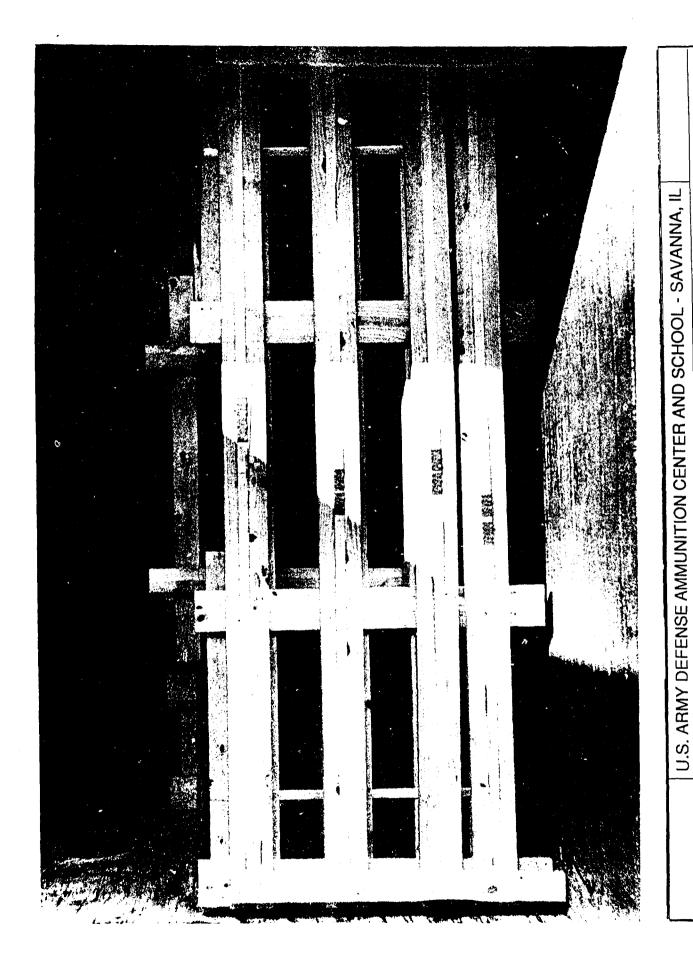
During the third rail impact at a speed of 8.08 mph, all four steel straps failed when the strap broke at the notch in the seal located 12 inches from the anchor device. The six pallets moved six inches forward, after the four steel straps separated.

Photo No. AO317-SPN-89-3732. View of the four 1 1/4-inch steel straps across the strapping gate restraining the

six pallets of propelling charges.

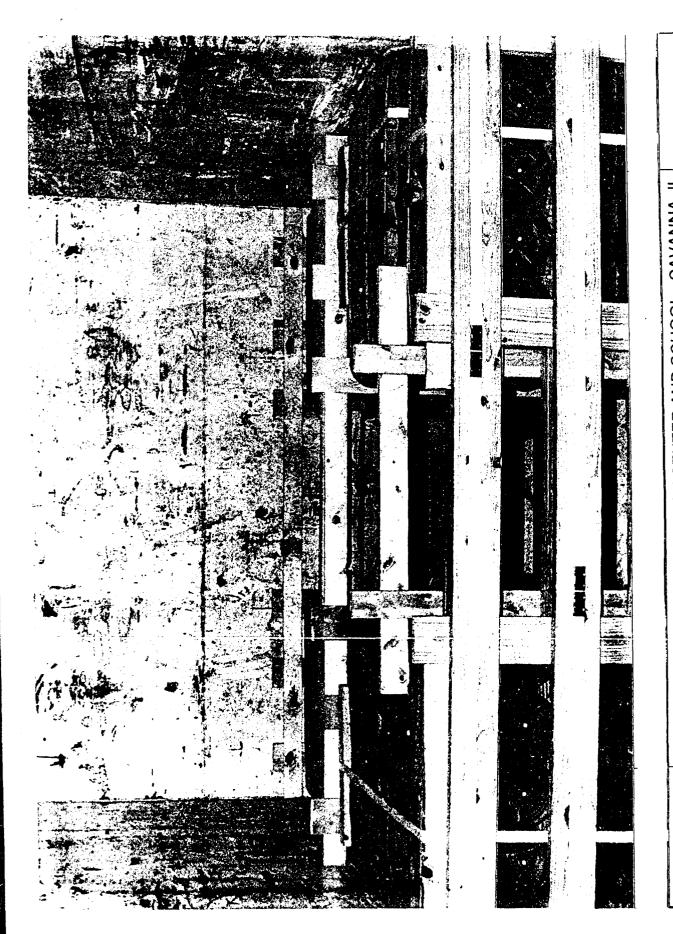
The rail impacts of 4,6, and 8 mph were performed with accumulated movement at the center of the strapping bulkhead gate of less than 1/2-inch. The four 1 1/4-inch steel straps restrained the 6,890-pound load.

Photo No. AO317-SPN-89-962-4193. View of the top two 1 1/4-inch steel straps of the four 1 1/4-inch straps used U.S. ARMY DEFENSE AMMUNITION CENTER AND SCHOOL - SAVANNA, IL

to restrain the four pallets of propelling charges.

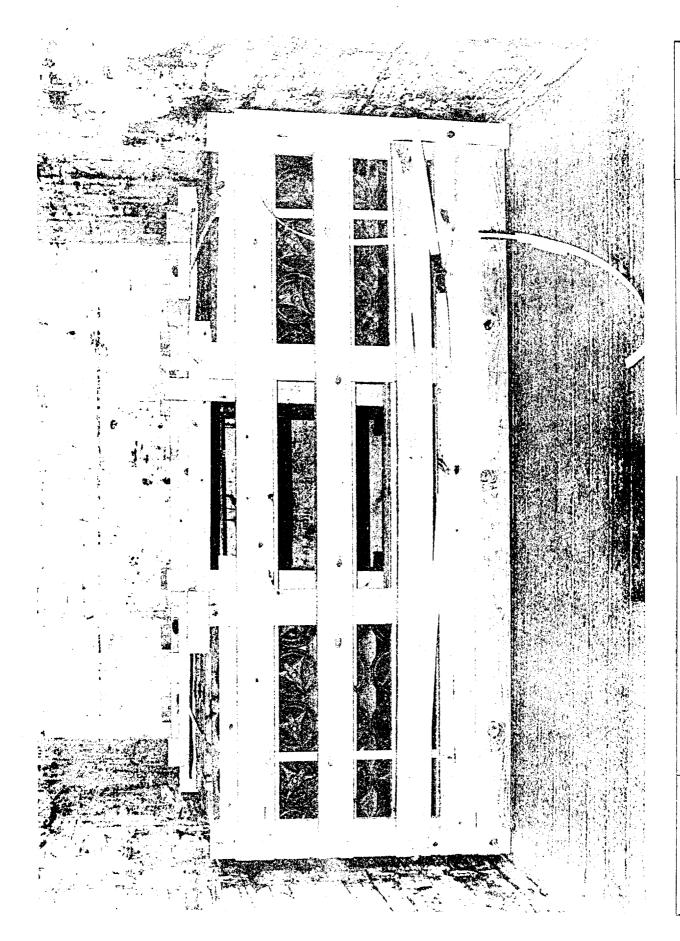
The load did not move during the 4.24 mph rail impact. The 6.10 mph rail impact resulted in the strapping gate rebounding 3/16-inch at the gate's center. The 8 mph rail impact was not measured, but it appeared to be close to the desired speed. Both remaining 1 1/4-inch steel straps failed through the crimp in the strap.

IMPACT NO.	END STRUCK	VELOCITY (MPH)	REMARKS
1	• '	4.24	No movement.
2	В	6.10	Strapping gate rebounded forward 3/16-inch at the gate's center.
3	В	Unknown	Both remaining bands failed through the crimp in the banding.  FAILURE

Photo No. AO317-SPN-89-692-4191. View of the failure of both of the 1 1/4-inch steel straps following the 8 mph U.S. ARMY DEFENSE AMMUNITION CENTER AND SCHOOL - SAVANNA, IL rail impact. Note: The strap was not doubled across the strapping gate.

- 2. Recommend that a bulkhead gate used in combination with two bands of 1 1/4-inch steel strapping not retain more than 4,500 pounds of load in a railroad boxcar.
- 3. Recommend the AAR/BOE's required 36 inches from the lading strap anchor to the face of the load be reduced to 33 inches needed for the reduced load restrained by the 1 1/4-inch strapping.
